# OMAP-L138 C6000 DSP+ARM® Processor Silicon Revisions 2.3, 2.1, 2.0, 1.1 and 1.0

## Silicon Errata

Literature Number: SPRZ301M  
June 2009–Revised March 2014

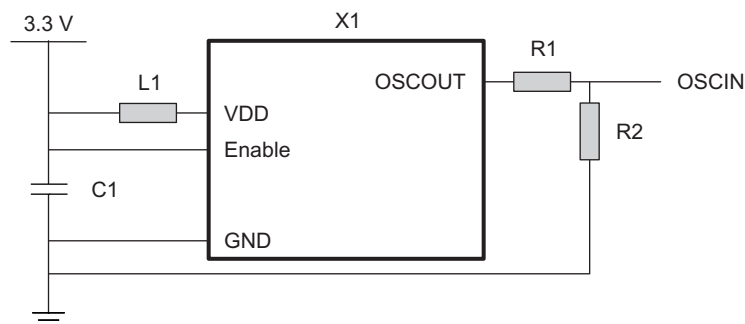
**Figure 2. External 3.3V Clock Source**

On all silicon revisions, certain design elements make this device susceptible to radiated noise during an ESD strike, as described in the standard IEC 61000-4-2. Exposure to the electrical noise caused by the ESD can cause soft device failures due to noise coupling on the system clock (OSCIN). ESD events within the IEC spec range do not cause permanent device damage and full functionality is recoverable with a device reset. The sensitivity to this noise issue is primarily due to the 1.2V oscillator/clock input implemented on this device. The low voltage range, coupled with slow rise and fall times, provides a lower noise margin than other TI devices with higher voltage internal oscillators (for example, 1.8V or 3.3V oscillators).

If ESD robustness is a concern, it is strongly recommended to avoid using the internal oscillator as a clock source. An external 3.3V clock source with a resistor voltage divider as in [Figure 2](#) can be used to externally generate the required 1.2V input clock. By using an external clock input with fast rise/fall times (less than 5 ns), the noise margin improves significantly, increasing ESD noise resistance.

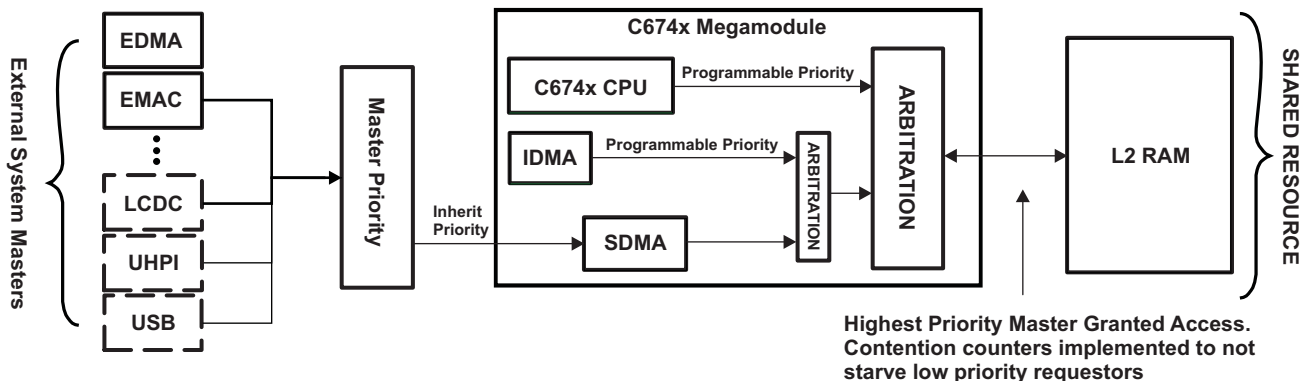
**Figure 3. Priority Arbitration Scheme for L2 RAM**

Ideally, the BWM arbitration will grant equal L2 bandwidth between equal priority DMA and CPU requests. Instead, when equal priority DMA and CPU requests arrive at the BWM, bandwidth is always granted in favor of the CPU over DMA. In the case of successive CPU requests, it is possible for the CPU to block all DMA requests until CPU traffic subsides. Additionally, some command logic in the BWM uses priority level 7, which can also result in SDMA stalls when the CPU is also programmed to priority level 7. [Figure 3](#) shows a high level diagram of the arbitration scheme used for L2 RAM requests.

**Workaround(s)** Configure DMA and CPU requests to different priority levels. There is no penalty for setting the IDMA and SDMA priorities equal to each other.

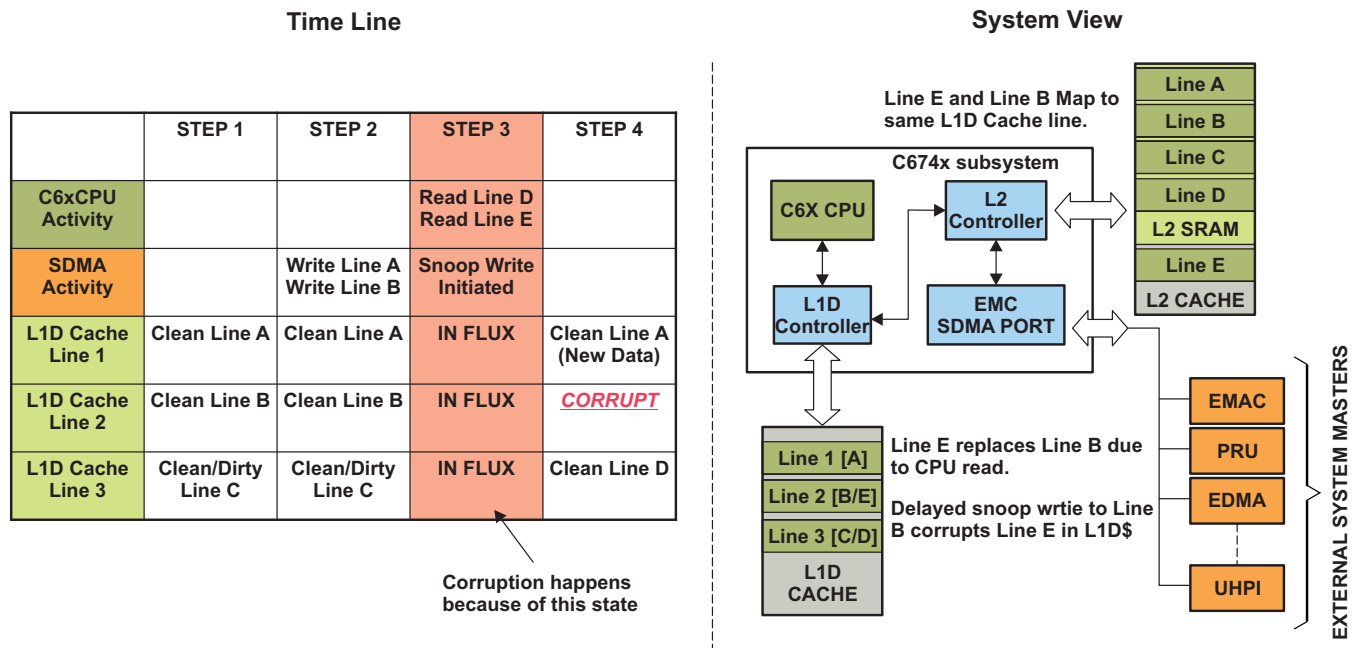
**Figure 4. Example of L1D Cache Corruption**

An L1D cache-line corruption event occurs when all of the conditions in the following steps are met (see [Figure 4](#)):

- Line E in L2 cache is read as a cache hit. Line E is destined to replace Line 2 in L1D Cache, which also has a snoop write pending for the updated Line B content.

- Line D in L2 SRAM is read. Line D will replace Line 3 in L1D cache.
4. When the snoop write operation completes, Line 2 in L1D cache now contains the updated L2 SRAM Line B data instead of the L2 cache Line E data.

The correct behavior would have been to kill the pending snoop write initiated to update L1D cache Line 2 with the updated L2 SRAM Line B data in Step 3. The L1D cache should have evicted Line B and replaced it with Line E data. Instead, the snoop write operation continues and does not complete until after the L1D cache Line 2 has already been replaced with L2 cache Line E data. The snoop write instruction overwrites the L1D cache Line 2 (containing L2 cache Line E data) with the updated L2 SRAM Line B data.

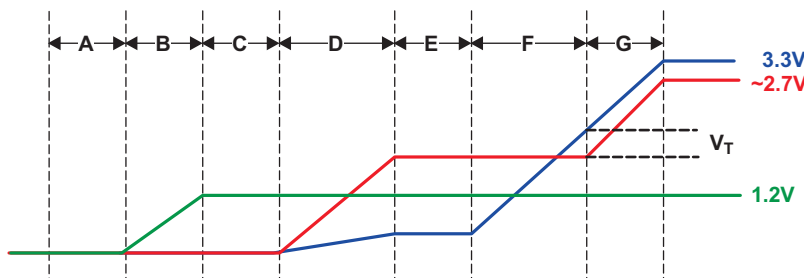
Figure 6. Faulty power-supply ramp

The behavior is the same until zone G. When the DVDD3318\_x supply exceeds DVDD18 by a transistor  $V_T$ , the DVDD18 supply begins to be pulled up by the DVDD3318\_x supply and follows the DVDD3318\_x supply by  $DVDD3318\_x - V_T$ . Since the DVDD18 supply is often connected to other 1.8V supplies in the design, these other supplies can be pulled up also.

1. Design simulation has indicated that under the worst-case process/voltage/temperature conditions the maximum leakage current into the DVDD18 supply due to this phenomenon will be 140 mA (the 140 mA is a cumulative current generated by all of the dual-voltage IOs). So this error state can be prevented by ensuring that the load on the DVDD18 supply during the DVDD13318\_x supply ramp exceeds 140 mA. This can be achieved by any combination of the following as long as they cumulatively produce >140 mA load on DVDD18 during the DVDD3318\_x ramp period:

- (a) Maintain sufficient bulk capacitance on the DVDD18 supply such that the charging current for these capacitors provides all or part of the required >140 mA. Bulk capacitance in this context means the total capacitance seen by the DVDD18 supply (filter capacitors, bypass capacitors, etc.). Capacitor charging current is defined as  $I = C \cdot (dV/dt)$ . So the ramp rate of the DVDD3318\_x supply and the total bulk capacitance on the DVDD18 supply can be used to calculate the current produced. This solution provides additional power supply filtering and little current leakage after the supplies are ramped (depending on the type of capacitors used).

2. Choose a regulator for the DVDD18 supply (or grouped 1.8V supplies) that is capable of actively regulating voltage up and down. Many high-efficiency switching regulators switch current into the load only when the voltage needs to be raised and rely on the load to pulldown the current. In this error condition, a regulator of this type will not be able to compensate for the leakage current described above. Synchronous buck regulators use external inductance to pulldown the regulated voltage when necessary.

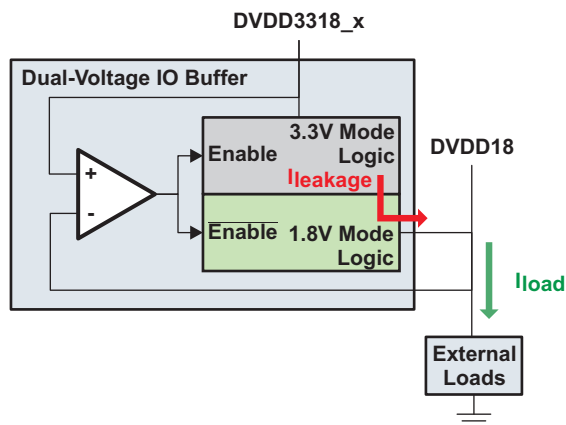
Figure 8. Error State of the IO buffer during Zone G

#### Error State of the IO buffer during Zone G:

As DVDD3318\_x exceeds DVDD18 +  $V_T$ , some of the circuitry across the boundary of the two voltage domains will turn on and causes a leakage current (in red) to flow between the two voltage domains. This current pulls up the DVDD18 supply unless the power source providing that supply can oppose it or unless the load current is strong enough to counteract it.

If DVDD18 continues to rise as DVDD3318\_x ramps, the comparator never sees enough difference between the two supplies to switch to 3.3V mode.

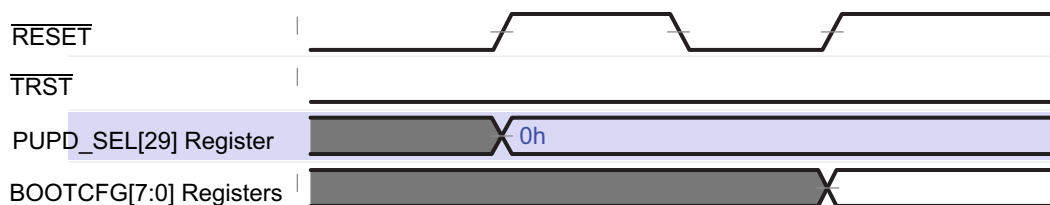
**Figure 10. Initialization of PUPD\_SEL[29] and BOOTCFG[7:0] Registers with Weak or No External Pull Resistors on BOOT[7:0] Pins**

Internal pullups being enabled on the BOOT[7:0] pins may result in boot failures. If weak external pulldown resistors are used on the PCB to select the boot mode, they may not be able to overpower the internal pullups. This can result in the wrong boot mode being latched in the BOOTCFG[7:0] register when coming out of Reset.

Once the device is out of Reset, the PUPD\_SEL[29] register is initialized, and the internal pulldown resistors for the BOOT[7:0] pins are all enabled. Issuing a second Power-On Reset ( $\overline{POR}$ ) results in the intended boot mode being latched, since the pins are internally pulled down as expected.

Figure 10 shows the behavior of the PUPD\_SEL[29] register before and after reset. Assuming weak or no external pull resistors are on the BOOT[7:0] pins, the BOOTCFG register will latch the unknown values after the device initially comes out of Reset. Note that, TRST **must** always be low in order to issue a POR and latch the boot pin values -- the boot pins are not latched after a Warm Reset.

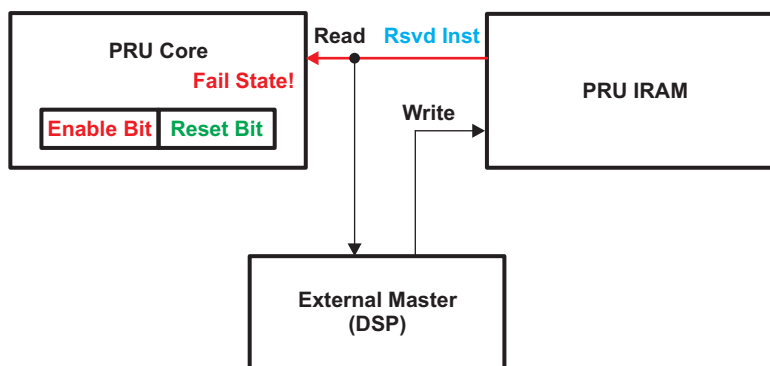
**Figure 14. Boot Failure on Power-On**

When the device is first powered-on, the read bus from the PRU IRAM is not initialized and will contain random values (see [Figure 14](#)). Under unpredictable circumstances, the random value on the read bus may resemble a reserved instruction which can be interpreted by the PRU when the core is reset and not enabled.

If the PRU core executes this reserved instruction, it will not be able to properly execute the first functional op-code in the PRU IRAM when the core is later enabled. In this fail state, the PRU will never acknowledge to the DSP that the reset vector table was successfully initialized and the DSP will be stuck in a polling loop waiting for the PRU to complete its task.

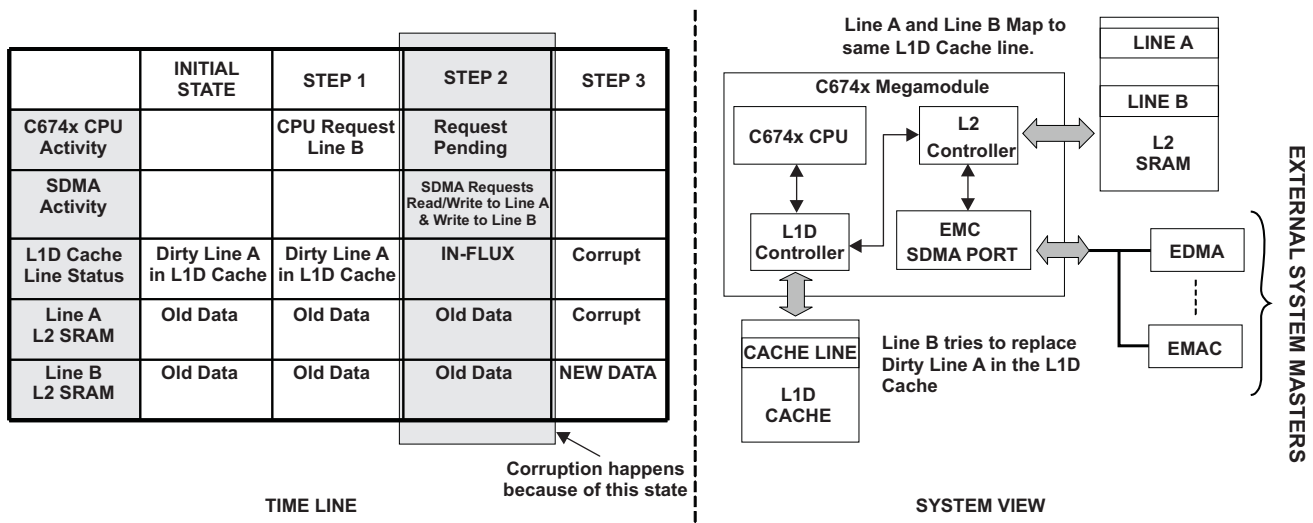
Figure 20. Example of L1D Cache and L2 RAM Corruption

1. L1D cache evicts a dirty line (Line A) while allocating a new line (Line B) in the same set/way (cache Lines A and B consist of 64-bytes each). In order for this to happen, the following will have taken place:
  - (a) Line A was previously read by CPU because L1D is a read-allocate cache,
  - (b) Line A is dirty because its value was modified by CPU, and
  - (c) Line B is read by CPU
2. Both Line A and Line B are associated with L2 RAM, and
3. While the original L1D victim write-back from condition (1) is in progress, the SDMA performs both:
  - (a) a read or write operation to Line A in L2 RAM and
  - (b) a write operation to Line B in L2 RAM.

If all of the above conditions are met, the L2 RAM data associated with the Line A victim writeback will become corrupt. Additionally, the Line B data originating from the SDMA write will also become corrupt in L1D cache. [Figure 20](#) shows an example scenario of L1D cache and L2 RAM corruption.

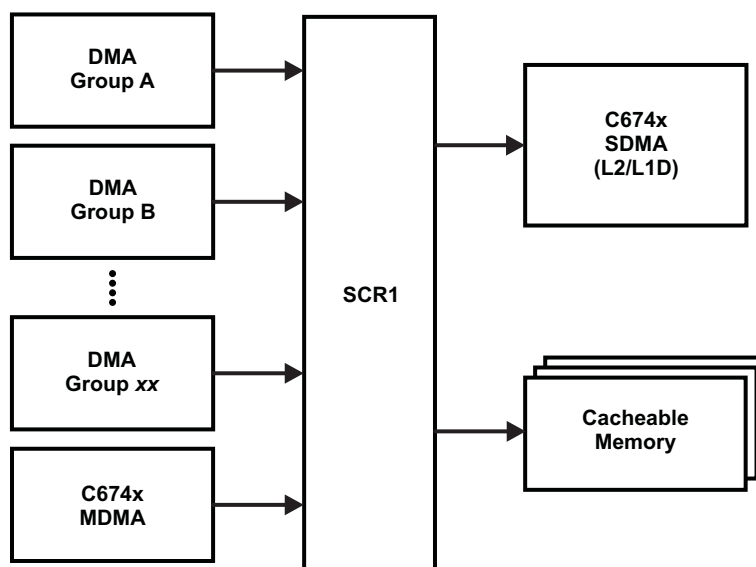
**Figure 22. SCR1 System Interconnect**

Step 2: The DSP's SDMA asserts itself as not ready and is unable to accept the write data from Step 1, and a cache line writeback is initiated from DSP memory to the same cacheable memory from Step 1. The cache line writeback command also passes through SCR1.

With the above scenario, it is possible for SCR1 to order the write commands from Step 1 in front of the write commands from Step 2. Due to the MDMA/SDMA blocking behavior, the SDMA commands from Step 2 will be waiting for the MDMA traffic from Step 1 to finish, resulting in a deadlock situation at SCR1. [Figure 22](#) is provided for illustrative purposes and is incomplete because of simplification.
