MSP430FG4250 Device Erratasheet

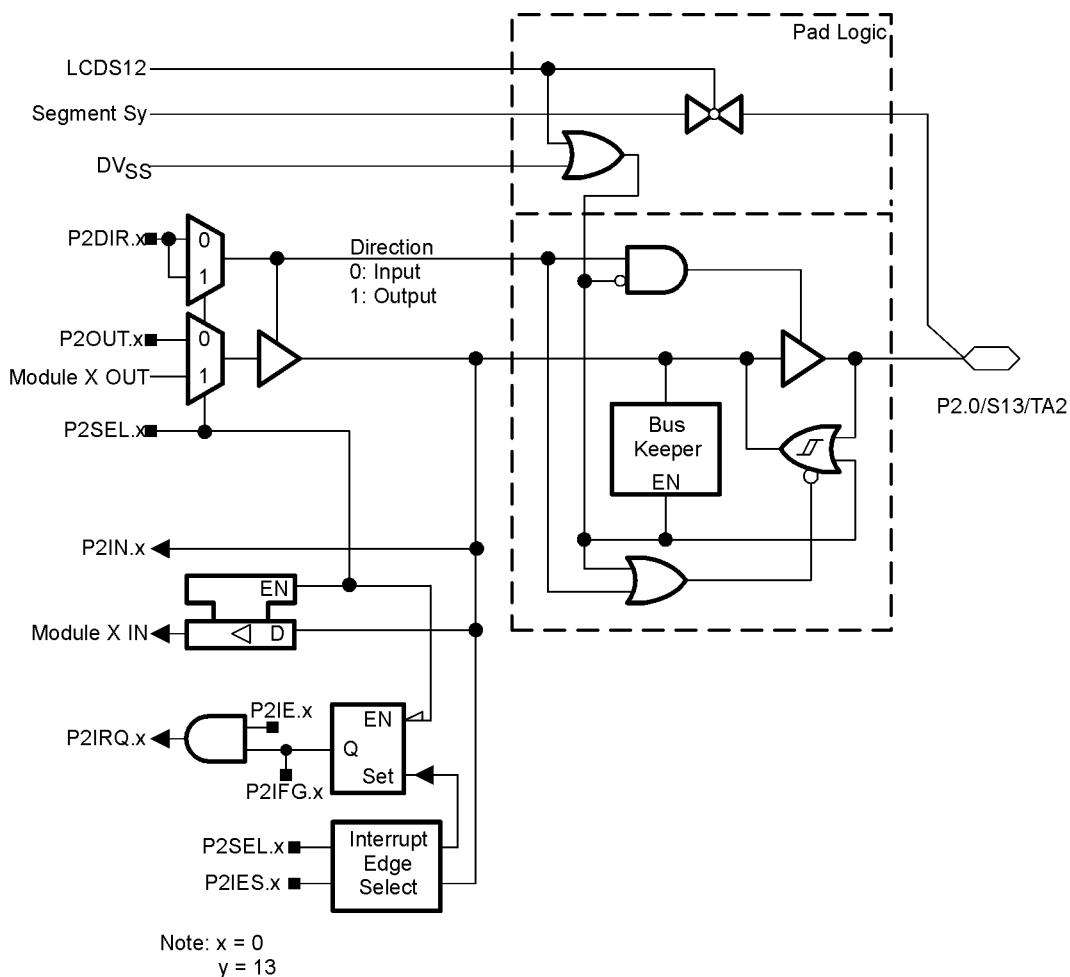
Description In addition to GPIO and LCD functionality, P2.0 also has Timer_A3 module output capability. When $\text{P2SEL.0} = 1$ and $\text{P2DIR.0} = 1$, P2.0 becomes a TA2 output.

PIN NAME (P2.X)	X	FUNCTION	CONTROL BITS / SIGNALS		
			P2DIR.x	P2SEL.x	LCDS12
P2.0/S13/TA2	0	P2.0 Input/Output	0/1	0	0
		N/A	0	1	0
		Timer_A3.TA2	1	1	0
		S13	X	X	1
