Errata

TMS320F2802x, TMS320F2802xx MCUs Silicon Revisions B, A, 0

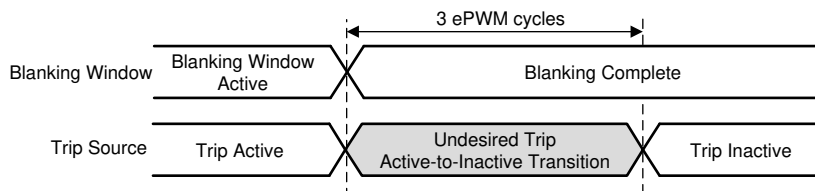
Figure 4-1. Undesired Trip Event and Blanking Window Expiration

The blanking window is typically used to mask any PWM trip events during transitions which would be false trips to the system. If an ePWM trip event remains active for less than three ePWM clocks after the end of the blanking window cycles, there can be an undesired glitch at the ePWM output.

Figure 4-1 illustrates the time period which could result in an undesired ePWM output.

Workaround(s) Extend or reduce the blanking window to avoid any undesired trip action.
