TMS320F2837xS Real-Time MCUs Silicon Errata

Silicon Revisions C, B

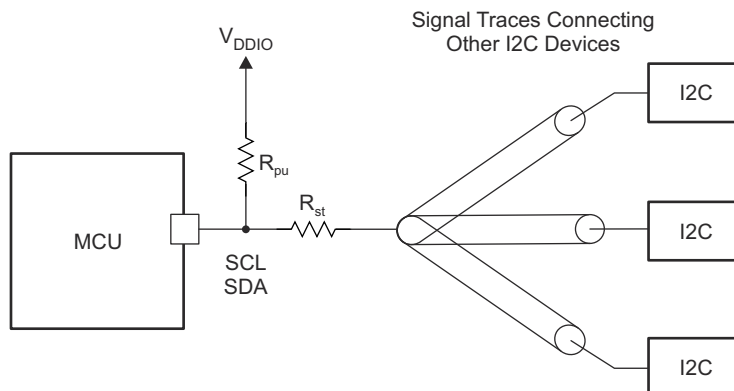
Figure 3-4. Placement of Series Termination Resistor and Pullup Resistor

The SDA and SCL outputs are implemented with push-pull 3-state output buffers rather than open-drain output buffers as required by I2C. While it is possible for the push-pull 3-state output buffers to behave as open-drain outputs, an internal timing skew issue causes the outputs to drive a logic-high for a duration of 0–5 ns before the outputs are disabled. The unexpected high-level pulse will only occur when the SCL or SDA outputs transition from a driven low state to a high-impedance state and there is sufficient internal timing skew on the respective I2C output.

This short high-level pulse injects energy in the I2C signals traces, which causes the I2C signals to sustain a period of ringing as a result of multiple transmission line reflections. This ringing should not cause an issue on the SDA signal because it only occurs at times when SDA is expected to be changing logic levels and the ringing will have time to damp before data is latched by the receiving device. The ringing may have enough amplitude to cross the SCL input buffer switching threshold several times during the first few nanoseconds of this ringing period, which may cause clock glitches. This ringing should not cause a problem if the amplitude is damped within the first 50 ns because I2C devices are required to filter their SCL inputs to remove clock glitches. Therefore, it is important to design the PCB signal traces to limit the duration of the ringing to less than 50 ns. One possible solution is to insert series termination resistors near the SCL and SDA terminals to attenuate transmission line reflections.

This issue may also cause the SDA output to be in contention with the slave SDA output for the duration of the unexpected high-level pulse when the slave begins its ACK cycle. This occurs because the slave may already be driving SDA low before the unexpected high-level pulse occurs. The glitch that occurs on SDA as a result of this short period of contention does not cause any I2C protocol issue but the peak current applies unwanted stress to both I2C devices and potentially increases power supply noise. Therefore, a series termination resistor located near the respective SDA terminal is required to limit the current during the short period of contention.

Insert series termination resistors on the SCL and SDA signals and locate them near the SCL and SDA terminals. The SCL and SDA pullup resistors should also be located near the SCL and SDA terminals. The placement of the series termination resistor and pullup resistor should be connected as shown in [Figure 3-4](#).

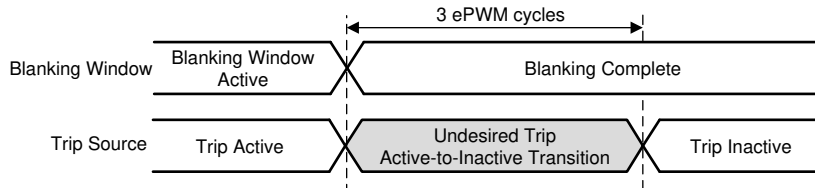
Figure 3-5. Undesired Trip Event and Blanking Window Expiration

The blanking window is typically used to mask any PWM trip events during transitions which would be false trips to the system. If an ePWM trip event remains active for less than three ePWM clocks after the end of the blanking window cycles, there can be an undesired glitch at the ePWM output.

Figure 3-5 illustrates the time period which could result in an undesired ePWM output.

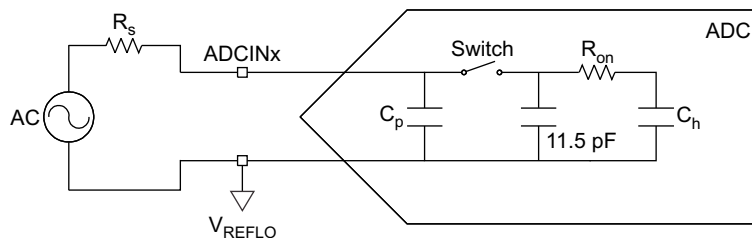
Figure 4-1. Single-Ended Input Model

The ADC input model should be used to select the sample-and-hold (S+H) duration for each ADC input. For the revisions affected, if the currently converting channel is an even-numbered channel and the previously converted channel was an odd-numbered channel (or vice versa), then the 12-bit input model will not accurately predict ADC input performance. Under these conditions, an additional capacitance should be added to the model. This capacitance has a value of 11.5 pF and should be placed between the S+H switch and R_{on} as shown in [Figure 4-1](#).
