Errata

MSP430F123 Microcontroller

This document describes the known exceptions to the functional specifications (advisories).

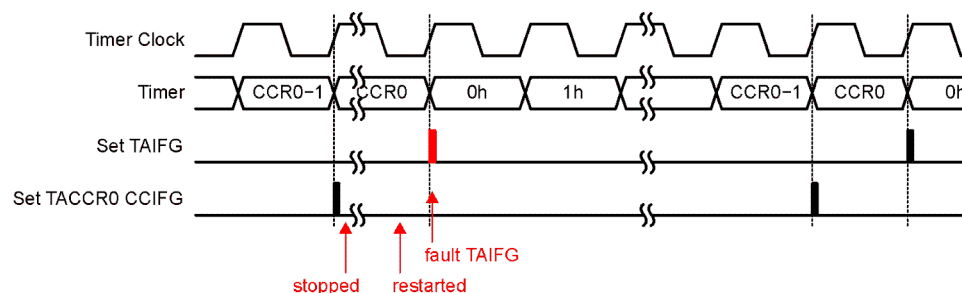
TA21 *TA Module*

Category	Functional
Function	TAIFG Flag is erroneously set after Timer A restarts in Up Mode
Description	In Up Mode, the TAIFG flag should only be set when the timer counts from TACCR0 to zero. However, if the Timer A is stopped at TAR = TACCR0, then cleared (TAR=0) by setting the TACLR bit, and finally restarted in Up Mode, the next rising edge of the TACLK will erroneously set the TAIFG flag.

Workaround	None.
-------------------	-------
