Errata

# AM62x Processor Silicon Revision 1.0

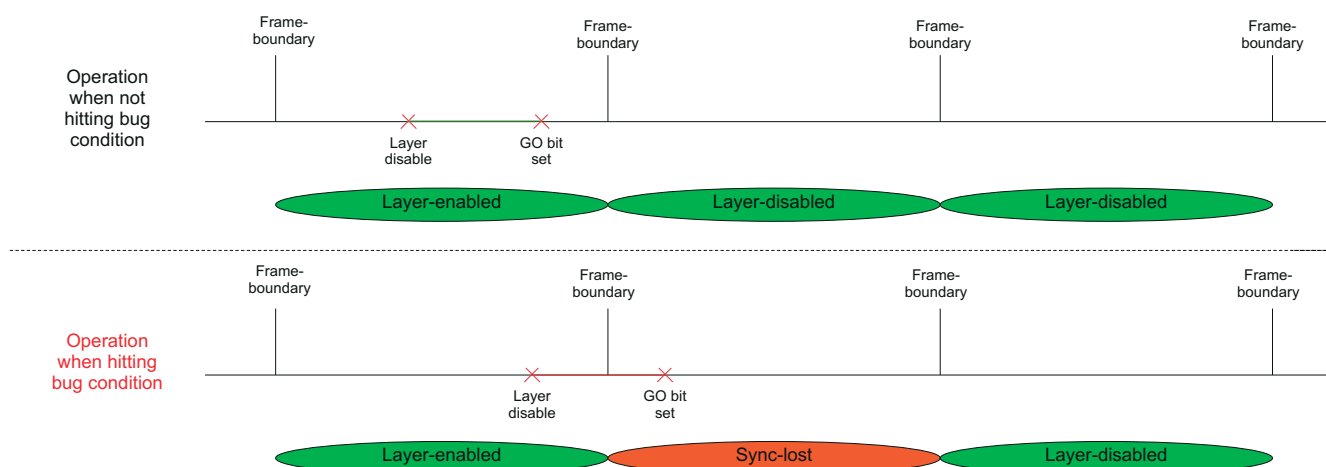
Figure 2-1. Bug Condition

Disabling a layer (for example VID1) connected to an OVR (that is toggling DSS\_VID\_ATTRIBUTESx[0] ENABLE from 1 to 0) may result in synclost during the next frame. The synclost may result in a corrupted or blank frame (all pixel data sent out of DSS during the frame is 0x0). The occurrence of synclost is dependent on the timing of setting the GO bit (that is DSS\_VP\_CONTROL[5] GOBIT to 1) vis-à-vis the disabling of the layer. If the “disable layer” MMR write operation and “set GO bit” MMR write operation happens within the same frame boundary, no synclost occurs. If the operations happen across the frame boundary, then synclost occurs (for one frame). The design automatically recovers and returns to normal operation from the next frame after GO bit is set, see [Figure 2-1](#).

A simple software workaround exists. In the workaround, prior to disabling a layer on the OVR, it is moved to the “non-visible” area of the OVR (for example: DSS\_OVR\_ATTRIBUTES\_x[17-6] POSX = max\_value\_of\_posx or DSS\_OVR\_ATTRIBUTES\_x[30-19] POSY = max\_value\_of\_posy). This avoids the synclost when the layer is disabled.

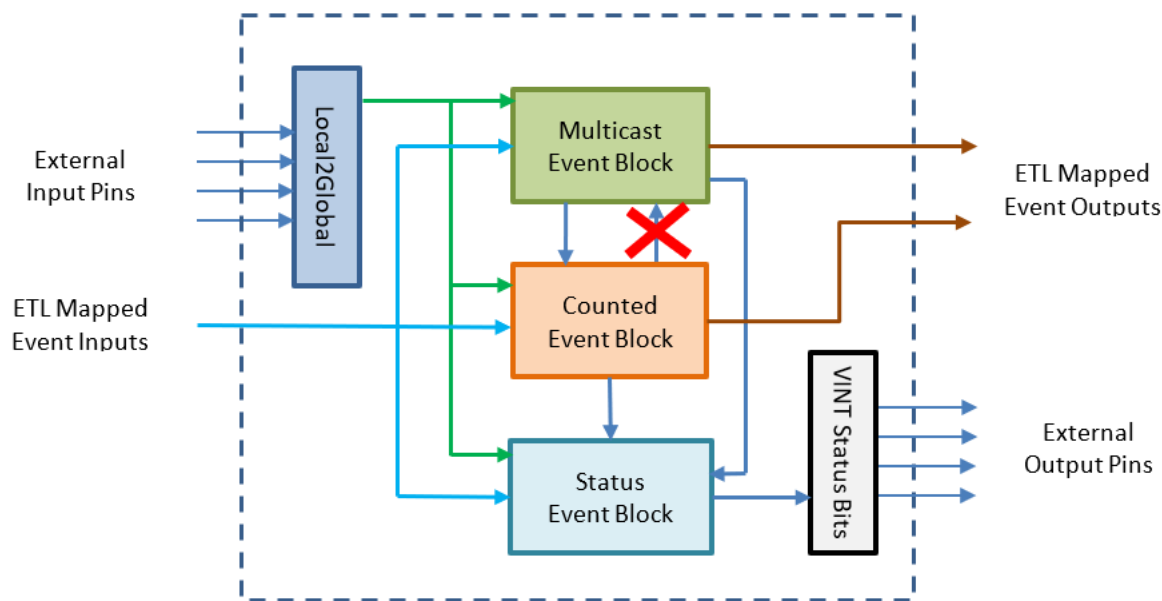
**Figure 2-3. Interrupt Aggregator Version 1.0**

An issue was found after design that could cause the IA to deadlock. The issue occurs when event “loops” occur between these three processing blocks. It is possible to create a situation where a processing block can not output an event because the path is blocked, and since it can not output an event, it can not take any new input events. This inability to take input events prevents the output path from being able to unwind, and thus both paths remain blocked.

Figure 2-3 shows the conceptual block diagram of IA 1.0. Potential loops are avoided by adopting the policy of not allowing the counted event block to send events to the multicast block. This method was chosen because it is more common to split an event first, and then count one while sending the other elsewhere. With this path blocked by convention, it is not possible for a single event to visit any block more than once and thus not possible for paths to become blocked so long as the outputs remain unblocked.

By following the conventions outlined here, the system is safe from looping hazards that can create a deadlock scenario.

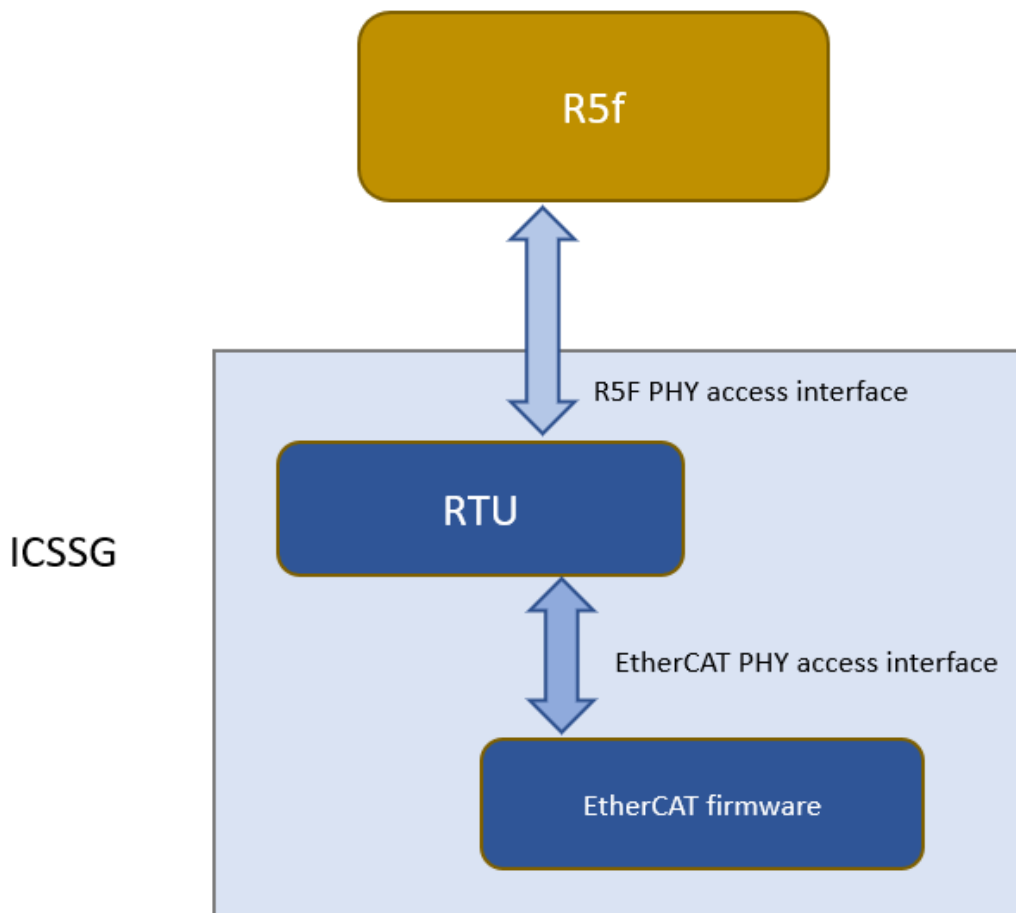
**Figure 2-4. MDIO Emulation via Manual Mode using PRU Core**

**MDIO: MDIO interface corruption (CPSW and PRU-ICSS)**
