Errata

MSP430G2203 Microcontroller

This document describes the known exceptions to the functional specifications (advisories).

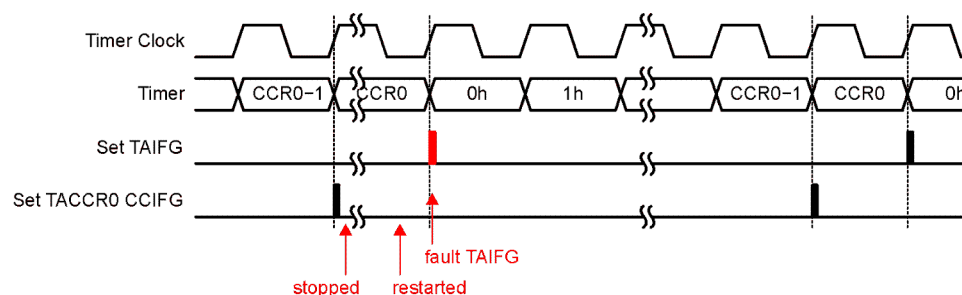
TA21 *TA Module*

Function TAIFG Flag is erroneously set after Timer A restarts in Up Mode

Description In Up Mode, the TAIFG flag should only be set when the timer counts from TACCR0 to zero. However, if the Timer A is stopped at $TAR = TACCR0$, then cleared ($TAR=0$) by setting the TACLR bit, and finally restarted in Up Mode, the next rising edge of the TACLK will erroneously set the TAIFG flag.

Workaround None.
