## Errata

# TMS320F2833x, TMS320F2823x Real-Time MCUs Silicon Errata (Silicon Revisions A, 0)

This document describes the known exceptions to the functional specifications (advisories). This document may also contain usage notes. Usage notes describe situations where the device's behavior may not match presumed or documented behavior. This may include behaviors that affect device performance or functional correctness.

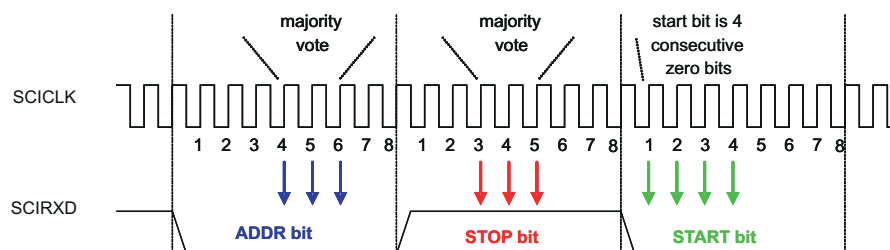
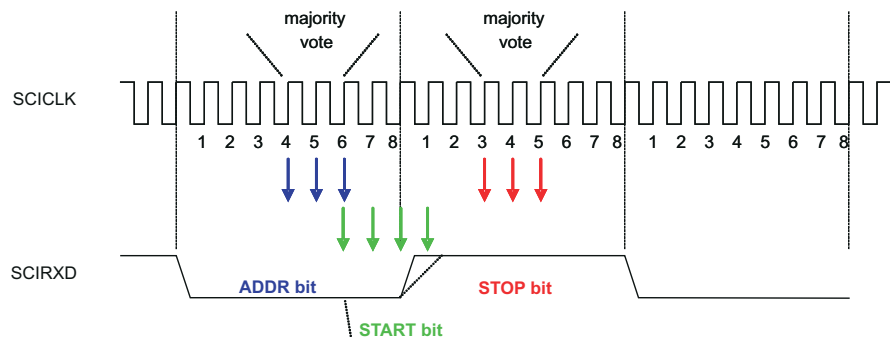
**Figure 3-1. Difference Between Expected and Erroneous Operation of START Bit**

SCI does not look for STOP bit after the ADDR bit. Instead, SCI starts looking for the start bit beginning on sub-sample 6 of the ADDR bit. Slow rise-time from ADDR to STOP bit can cause the false START bit to occur since the 4th sub-sample for the start bit may be sensed low.

Program the baud rate of the SCI to be slightly slower than the actual. This will cause the 4th sub-sample of the false START bit to be delayed in time, and therefore occur more towards the middle of the STOP bit (away from the signal transition region). The amount of baud slowing needed depends on the rise-time of the signal in the system. Alternatively, IDLE mode of the SCI module may be used, if applicable.

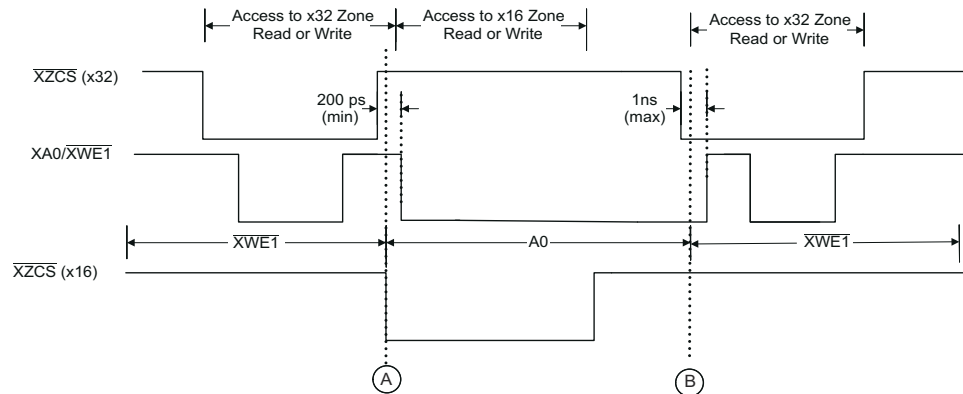
**Figure 4-1. Behavior of Zone Chip Select Signals and XA0/  $\overline{\text{XWE1}}$**

Figure 4-1 shows the behavior of zone chip select signals and XA0/  $\overline{\text{XWE1}}$  for back-to-back accesses between zones configured for different data bus widths.

- A. Design simulation data indicates the delta between  $\overline{\text{XZCS}}$  (x32) high and XA0/  $\overline{\text{XWE1}}$  low can be as small as 200 ps.
- B. Design simulation data indicates XA0/  $\overline{\text{XWE1}}$  can stay low for as long as 1 ns after  $\overline{\text{XZCS}}$  (x32) goes low.

The timing configuration of the x32 zone must account for the additional delay. The zone chip select delay may require additional lead time. The  $\overline{XWE1}$  delay enable may require additional active write time. In addition, specify at least 1 trail cycle for writes to the x32 zone.

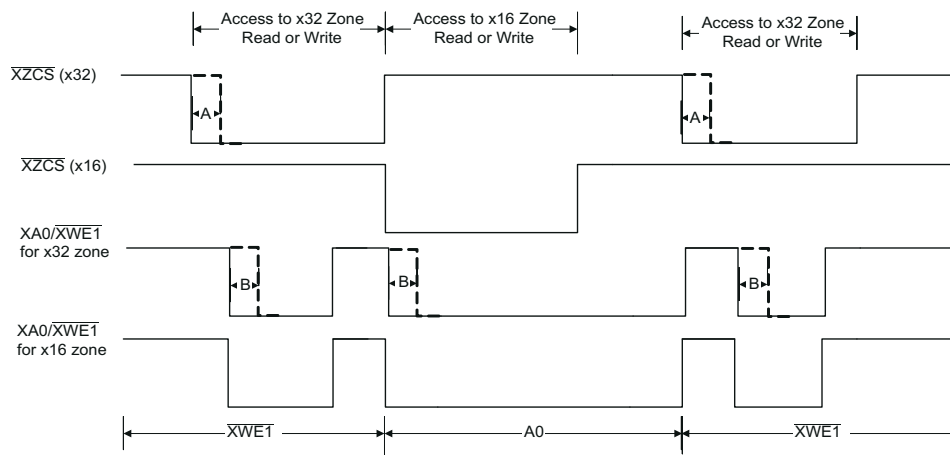
**Figure 4-2. Behavior After Application of Delay**

- A. Delayed falling edge of zone chip select for x32 zone.
- B. Delayed falling edge of  $\overline{XWE1}$ . The x16 zone will not see this delay.
