Errata TMS320F28004x Real-Time MCUs Silicon Errata Silicon Revisions B, A, 0

ABSTRACT

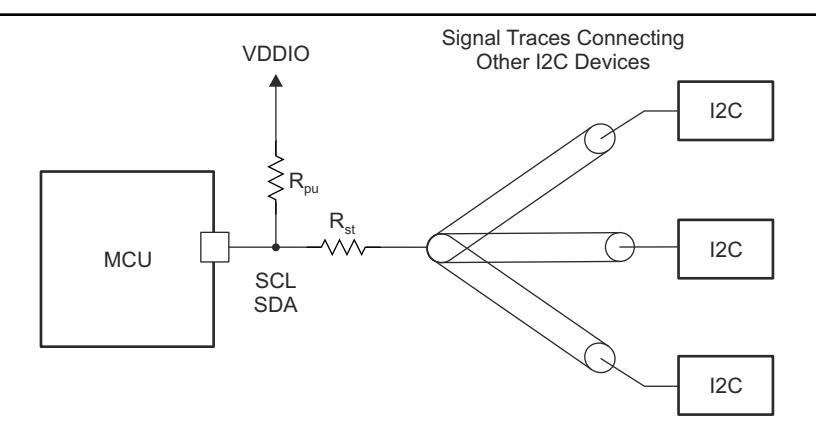
Advisory (continued) I2C: SDA and SCL Open-Drain Output Buffer Issue

The SDA and SCL outputs are implemented with push-pull 3-state output buffers rather than open-drain output buffers as required by I2C. While it is possible for the push-pull 3-state output buffers to behave as open-drain outputs, an internal timing skew issue causes the outputs to drive a logic-high for a duration of 0–5 ns before the outputs are disabled. The unexpected high-level pulse will only occur when the SCL or SDA outputs transition from a driven low state to a high-impedance state and there is sufficient internal timing skew on the respective I2C output.

This short high-level pulse injects energy in the I2C signals traces, which causes the I2C signals to sustain a period of ringing as a result of multiple transmission line reflections. This ringing should not cause an issue on the SDA signal because it only occurs at times when SDA is expected to be changing logic levels and the ringing will have time to damp before data is latched by the receiving device. The ringing may have enough amplitude to cross the SCL input buffer switching threshold several times during the first few nanoseconds of this ringing period, which may cause clock glitches. This ringing should not cause a problem if the amplitude is damped within the first 50 ns because I2C devices are required to filter their SCL inputs to remove clock glitches. Therefore, it is important to design the PCB signal traces to limit the duration of the ringing to less than 50 ns. One possible solution is to insert series termination resistors near the SCL and SDA terminals to attenuate transmission line reflections.

This issue may also cause the SDA output to be in contention with the slave SDA output for the duration of the unexpected high-level pulse when the slave begins its ACK cycle. This occurs because the slave may already be driving SDA low before the unexpected high-level pulse occurs. The glitch that occurs on SDA as a result of this short period of contention does not cause any I2C protocol issue but the peak current applies unwanted stress to both I2C devices and potentially increases power supply noise. Therefore, a series termination resistor located near the respective SDA terminal is required to limit the current during the short period of contention.

A similar contention problem can occur on SCL when connected to I2C slave devices that support clock stretching. This occurs because the slave is driving SCL low before the unexpected high-level pulse occurs. The glitch that occurs on SCL as a result of this short period of contention does not cause any I2C protocol issue because I2C devices are required to apply a glitch filter to their SCL inputs. However, the peak current applies unwanted stress to both I2C devices and potentially increases power supply noise. Therefore, a series termination resistor located near the respective SCL terminal is required to limit the current during the short period of contention.
