# OMAP-L138 C6000 DSP+ARM® Processor Silicon Revisions 2.3, 2.1, 2.0, 1.1 and 1.0

## Silicon Errata

Literature Number: SPRZ301M  
June 2009–Revised March 2014

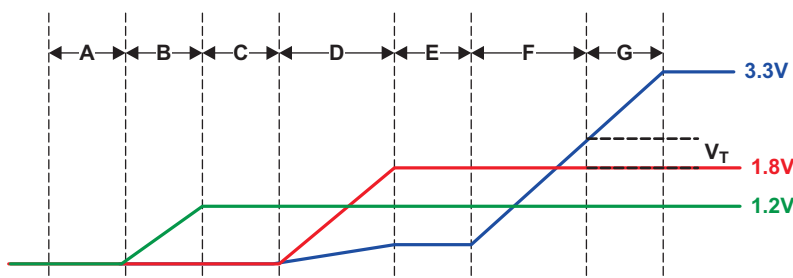
Figure 5. Normal power-supply ramp

**Important Note:** The 3.3V DVDD3318\_x supplies must not be driven to 0V during zones A – E or high current capable of damaging the device may occur. The 3.3V DVDD3318\_x supplies should not be driven during this time.

- A. All device supplies are undriven
- B. The 1.2V supplies are ramped to their nominal levels
- C. Potential delay between supply ramps (not required)
- D. The 1.8V supplies (specifically DVDD18) are ramped to their nominal levels. During the DVDD18 ramp there will be some minor drift up in the undriven DVDD3318\_x supplies. This is normal and is not a problem.
- E. Potential delay between supply ramps (not required)
- F. DVDD3318\_x is ramping but is less than DVDD18 +  $V_T$
- G. DVDD3318\_x is ramping but is greater than DVDD18 +  $V_T$

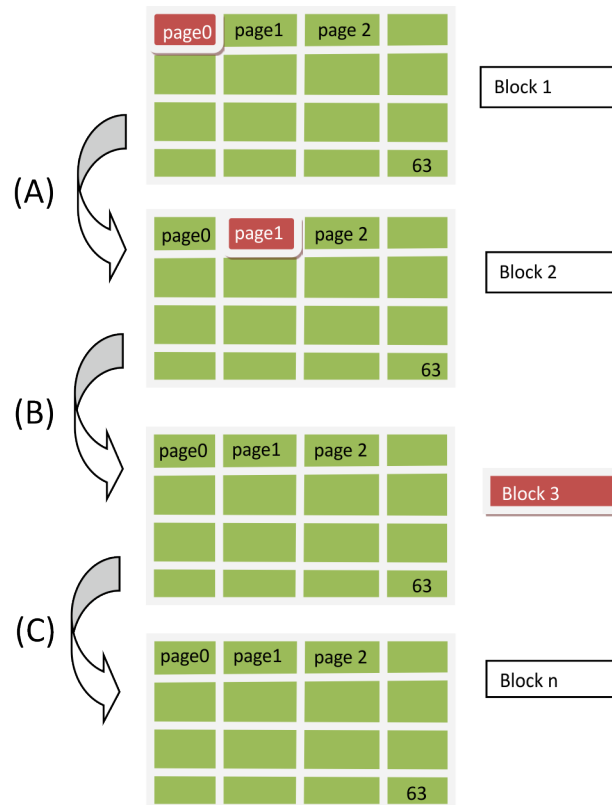
**Figure 12. D800K008 ROM Behavior With Software Patch Applied<sup>(1)</sup>**

Once the patch is read, all subsequent page reads in the block will use the new ECC Correct and Read functions. ECC data errors on any page (other than page0) are ignored, any user data error (up to 4 bit errors total) is corrected and the boot process continues. If an uncorrectable error is detected on any page, the block is skipped and the boot process is restarted on the next good block. The behavior of the device boot from the NAND after application of the patch is shown in [Figure 12](#).

(1) All pages marked in **green** are good and all pages marked in **red** have "uncorrectable" errors.

This workaround is implemented using a software patch that is loaded in device RAM at boot time and is designed to change the default behavior of the ECC Correct and Read functions in the RBL. The patch binary replaces function pointers to the ECC Correct and Read functions in the ROM function table, (defined in device internal memory), during boot. The patch binary will reside in page0 of the NAND block and so will be applied only after the page0 of a good block has been read.

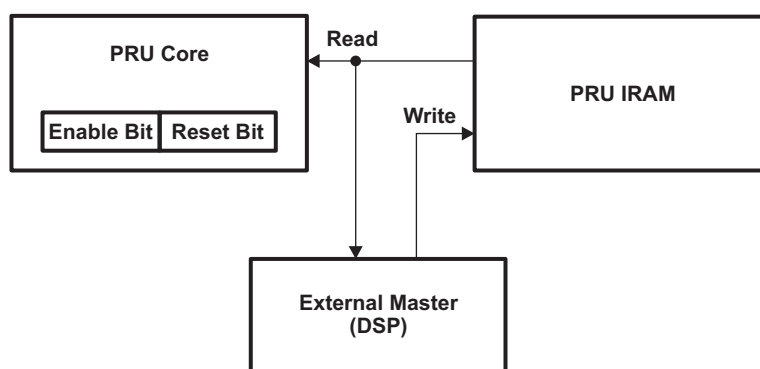
**Figure 13. PRU and DSP Block Diagram**

The ARM reset vector table is located in the ARM's local RAM, however the ARM local RAM can only be accessed by two bus masters: ARM and PRU0. Therefore, the DSP must program PRU0 to copy the desired reset vector table into the ARM's local RAM.

The PRU instructions are located inside of an instruction RAM (IRAM) which is initialized by the DSP during ROM boot (see [Figure 13](#)). After the instructions are stored to IRAM, the PRU is reset and enabled to execute its instructions. In this case, the PRU is instructed to initialize the ARM reset vector table.

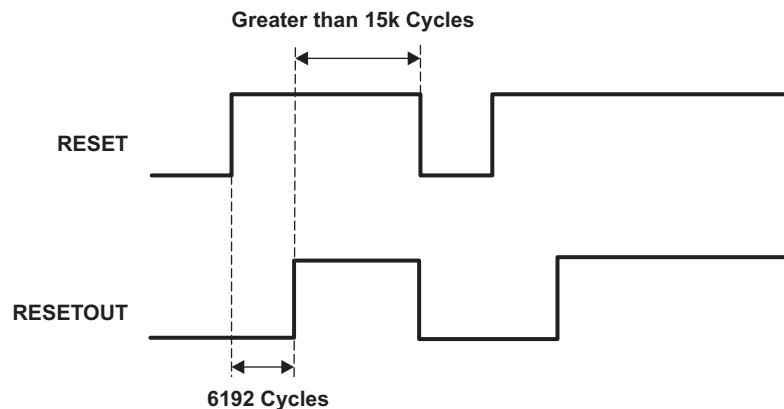
**Figure 16. First POR Reset Timing**

Note that in order to recover from this fail state with a secondary reset, the DSP must be allowed to execute its boot ROM up to the point where the PRU has fetched a known instruction from the PRU IRAM. The approximate count of 15k cycles into the boot ROM is sufficient.

The 15k clock cycle count does not include the 6192 clock cycles required to complete a device POR reset (see [Figure 16](#)). With a 24MHz crystal, the first RESET signal must be asserted high for at least 883us (or approximately 1ms).

Modify the target board so that the affected device is given a secondary reset on power-up as shown in [Figure 16](#). Two example methods are described in the sections that follow.

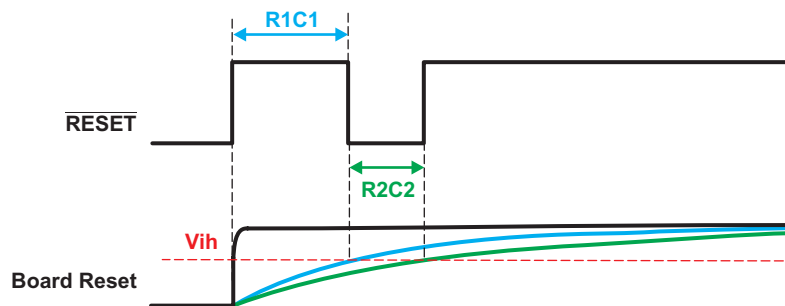
**Figure 19. RESET Signal vs Board Reset**

This is possible because each RC load connected to the board reset control signal can output a different rising-edge waveform. With increasing RC load, the resulting control signal will reach the Schmitt buffers'  $V_{ih}$  level at a later point in time. Figure 19 shows the relationship between the board reset signal and the RESET signal produced by the circuit. The blue and green lines represent the voltage as seen by the Schmitt buffers. The output voltage of a charging RC circuit is defined as:  $V_o = V_i * (1 - e^{-t / RC})$

Given ideal conditions, a 3.3V board reset signal, and an input buffer Vih of 1.4V, the following set of component values would generate an initial RESET high period (R1C1 region) of approximately 2ms and a RESET low period (R2C2 region) of approximately 0.5ms:

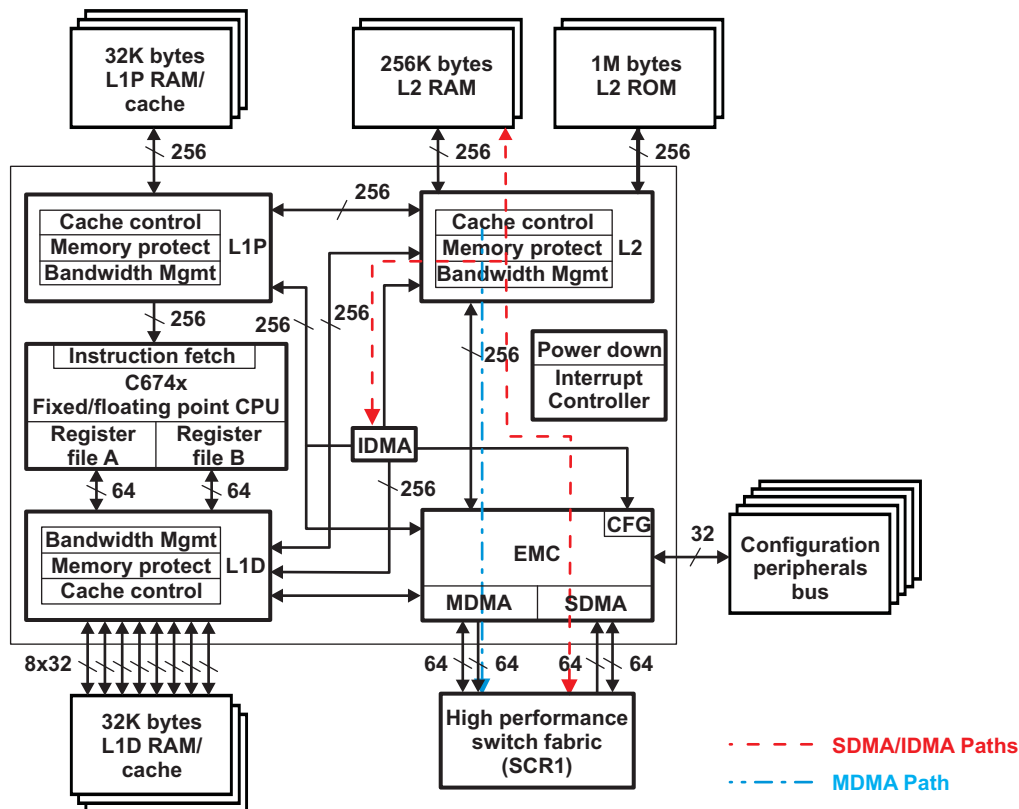
**Figure 21. C674x Megamodule**

Ideally, the MDMA (dashed-dotted line in Figure 21) and SDMA/IDMA paths (dashed lines in Figure 21) operate independently with minimal interference. Normally MDMA accesses may stall for extended periods of time due to expected system level delays (for example, bandwidth limitations). However, when using L2 as RAM, SDMA and IDMA accesses to L2/L1 may experience unexpected stalling in addition to the normal stalls seen by the MDMA interface. For latency-sensitive traffic, the SDMA stall can result in missing real-time deadlines. In a more severe case, the SDMA stall can produce a deadlock condition in the device. An IDMA stall cannot produce a deadlock condition.

**Note:** SDMA/IDMA accesses to L1P/D will not experience an unexpected stall if there are no SDMA/IDMA accesses to L2. Unexpected SDMA/IDMA stalls to L1 happen only when they are pipelined behind L2 accesses. Additionally, the deadlock scenario will be avoided if there are no SDMA accesses to L2.

Figure 21 is provided for illustrative purposes and is incomplete because of simplification. The IDMA/SDMA (dashed-lines) path could also go to L1D/L1P memories, and IDMA can go to DSP CFG peripherals. MDMA transactions can originate also from L1P or L1D through the L2 controller or directly from DSP).

The duration of the SDMA/IDMA stalls depend on the quantity/characteristics of the L1/L2 cache and the MDMA traffic in the system. Therefore, it is difficult to predict if stalling will occur and for how long.
