# **MSP430™ System-Level ESD Troubleshooting Guide**

## **ABSTRACT**

System-level electrostatic discharge (ESD) immunity, as one part of electromagnetic compatibility (EMC), has become more and more important in our daily lives with most electrical products. The MSP430™ microcontroller (MCU) portfolio offers a wide variety of 16-bit MCUs with ultra-low-power and integrated analog and digital peripherals for sensing and measurement applications. This application report introduces the concepts of system-level ESD immunity tests, troubleshooting guidelines, and a failure analysis procedure when encountering system-level ESD problems with MSP430 devices.

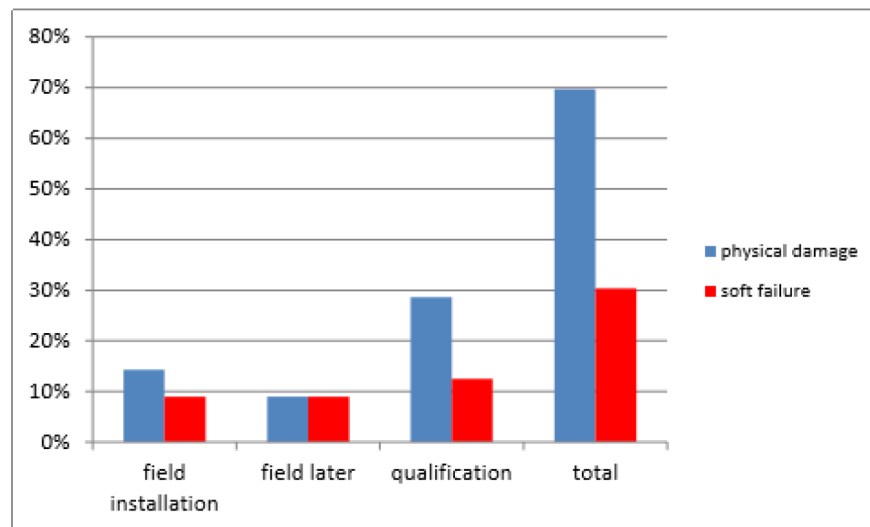
As mentioned in [Section 2](#), system-level ESD can result into two failure categories: 1) physical damage and 2) soft failure. [Reference \[5\]](#) studied 58 system-level ESD cases, which covered the full range from system qualification, to field installation and field failure after installation. [Figure 4](#) shows the two failure types seen from these 58 system-level ESD cases.

**Figure 4. Types of Failures and When Failure Occurred of System-Level ESD**

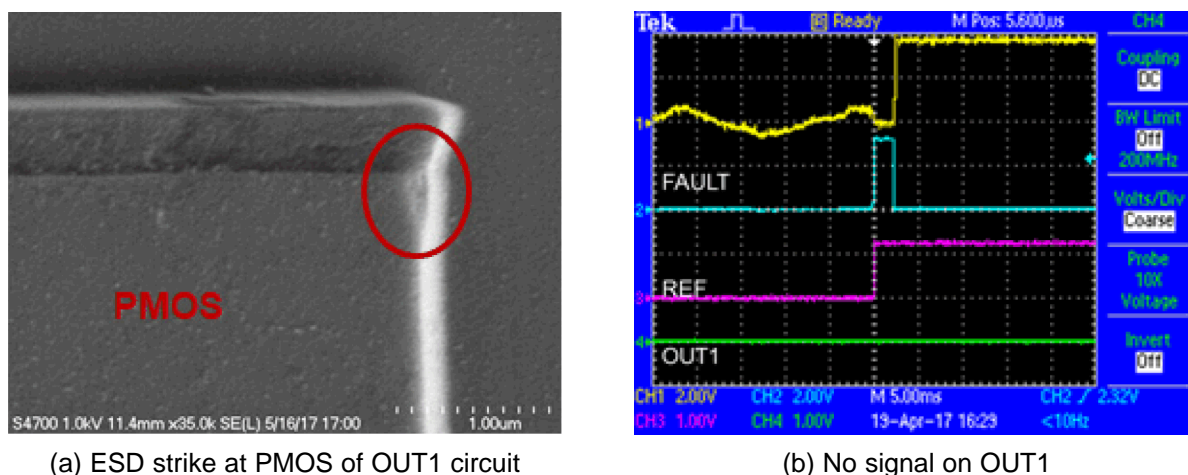
Failure analysis is a good tool to disclose if there was physical damage caused by the system-level ESD. This damage can present as an abnormal electrical signal detected by, or example, ATE or bench test. [Figure 7](#) shows an example of PMOS damage by a system-level ESD test that caused abnormal output. Because the power of the ESD strike is not enough to cause a large damage area on silicon die, it can be difficult to visualize small damage on die, like the tiny damage of the PMOS case. It may apply more efficient to use failure isolation techniques (for example, IR, LSM, EMMI, or probing) and sample preparation methods (for example, backside analysis or FIB) to limit the analysis time consumed.

Figure 7. Images of System-Level ESD Failure Case

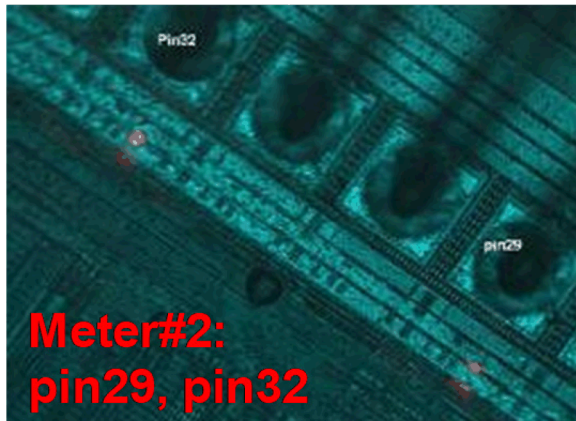
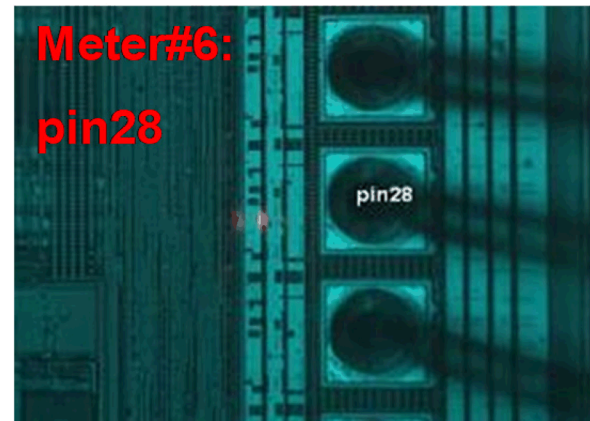
Six failed meters were analyzed, and meter 1 was selected to trial the sample preparation and handling with lesson learn for improper handling. The remaining five failed meters (meter 2 to meter 6) were successfully prepared to expose the MCU die for the hot spot analysis. Figure 11 shows the typical hot spot images. The emission hot spots were observed at the MCU LCD pins of failed meters (see Table 3).

(a) Image of meter 2

(b) Image of meter 6

**Figure 11. Emission Hot Spot Images of MCU Die**
